MARINE SURVEY OF CONDITION

TYPE OF VESSEL: Ketch rigged, auxiliary, cruising sailboat, Island Freeport 41

BUILDER: Islander Yacht
Costa Mesa, CA

DOCUMENTATION: NO1032488
VESSEL NAME: Family Ties

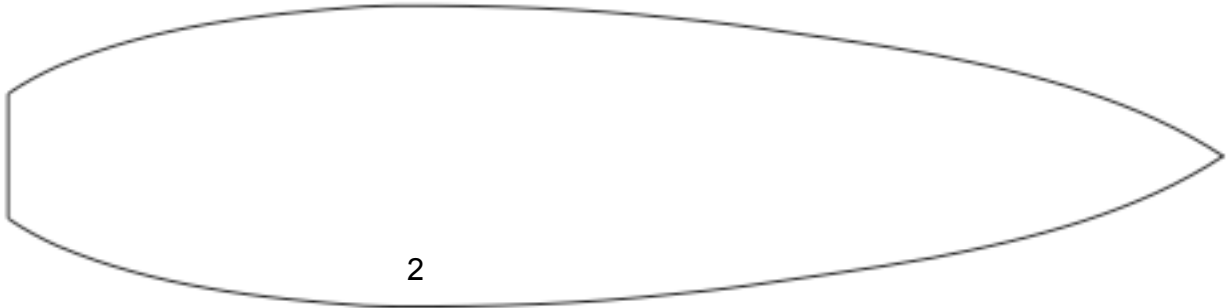
DECK FILLS AND FITTINGS: DESCRIPTION (Marked)

1. Waste
2. Fuel (Diesel or Gas)
3. Water

NOTE: All deck fills and fittings should be inspected minimally, annually. All hoses and clamps should also be inspected for deterioration, and replacements made as found.

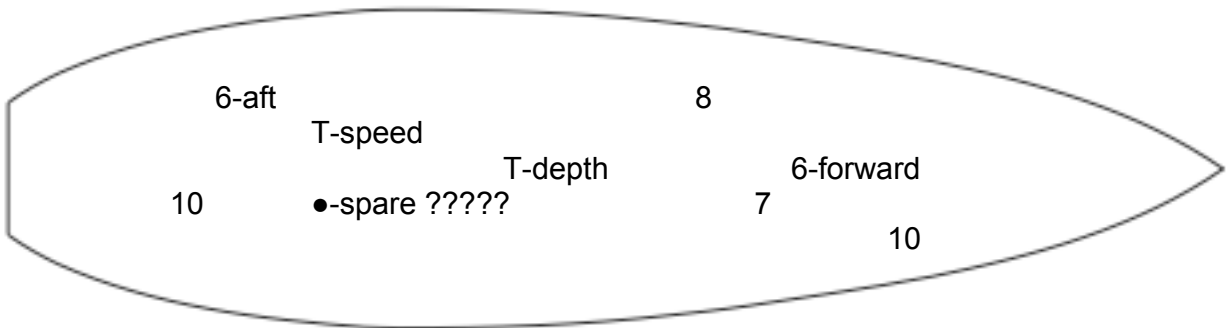
THRU-HULLS: RELATIVE POSITIONS: DESCRIPTION:

| 9. Scuppers | 10. Direct head drain |

T=Transducer (s) S=Speed D=Depth

NOTE: All sea valves should be exercised minimally annually and inspected for hose, valve, and clamp deterioration, and replacements made as found. All valves should have an attached soft pine bung for damage control purposes. All valves of this type should be taken down and lubricated minimally of every other year to facilitate

THRU-HULLS:
10 Bronze below the waterline ball valves, observed, visually inspected, double hose clamped
2 Transducers
